**15<sup>th</sup> International Conference  
on Applied Mechanics and  
Mechanical Engineering.**

## **MICROSTRUCTURAL IMPRINTS IN FAILURE OF POWER PLANT BOILER TUBES**

U. K. Chatterjee\*

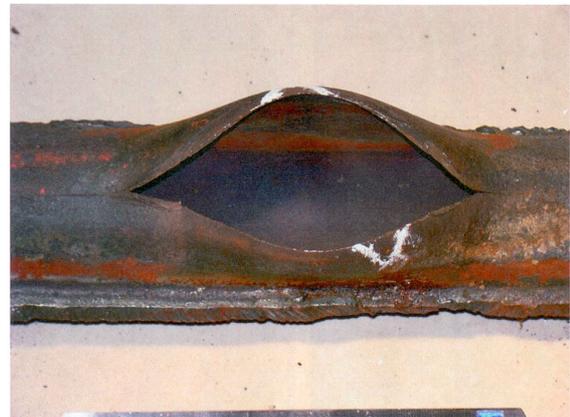
Fig. 4 shows the general view of a rupture with thin lips indicating a ductile fracture. The microstructure of the unaffected portion showed a normal ferritic-pearlitic structure (Fig. 5). The affected area showed martensitic structure (Fig. 6) bearing a testimony to overheating above  $AC_1$  temperature that softened the material leading to ductile fracture.

**Fig. 4.** Thin-lip ductile rupture of a waterwall tube.

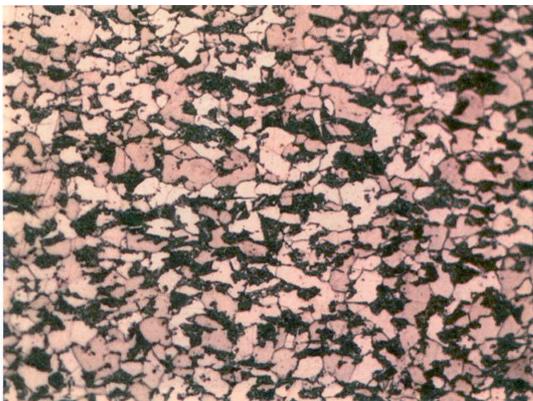
**Fig. 5.** Microstructure of unaffected portion showing normal ferrite-pearlite structure,

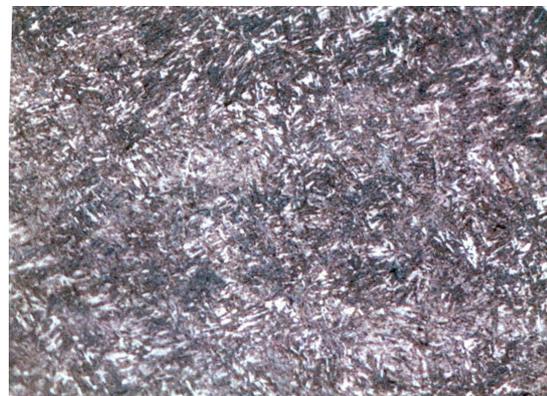
**Fig. 6.** Microstructure of lip portion showing martensite, 200x.

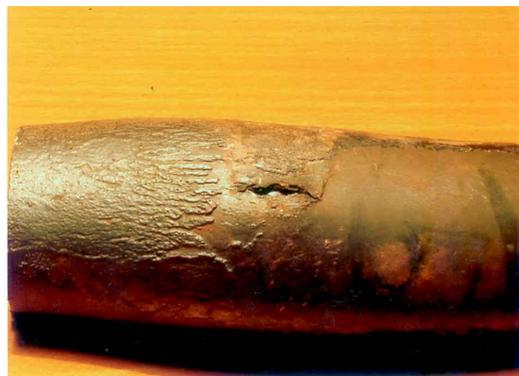
An economizer tube made of SA-192 developed a slit after a service life of 20 years (Fig. 12). The microstructure revealed intact colonies of disintegrated pearlite and graphite (Fig. 13), typical of graphitization at low temperatures.

**Fig. 12.** Slit formation in an economizer tube due to graphitization.

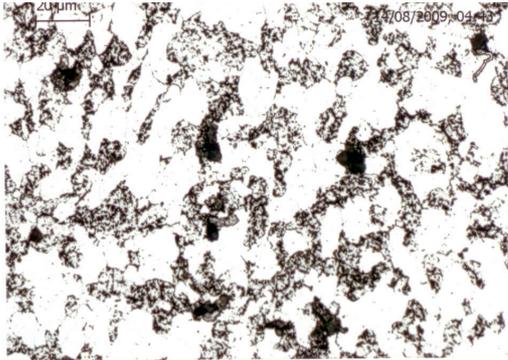
**Fig. 13.** Colonies of disintegrated pearlite and graphite—graphitization at low temperatures, 500x.

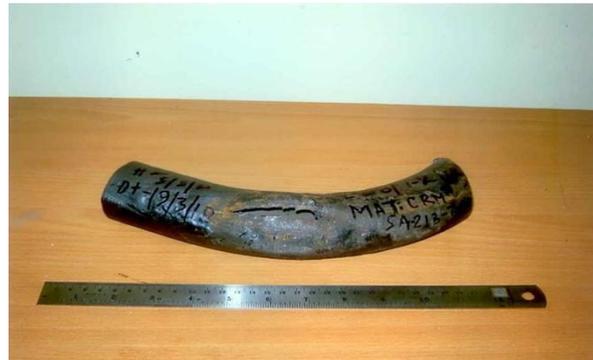
Thick lip rupture was experienced in a superheater tube after prolonged service (Fig. 14). The microstructure showed complete spheroidization preceding graphitization (Fig. 15), typical of graphitization at higher temperatures.

**Fig. 14.** Thick-lip rupture of a superheater tube due to graphitization.

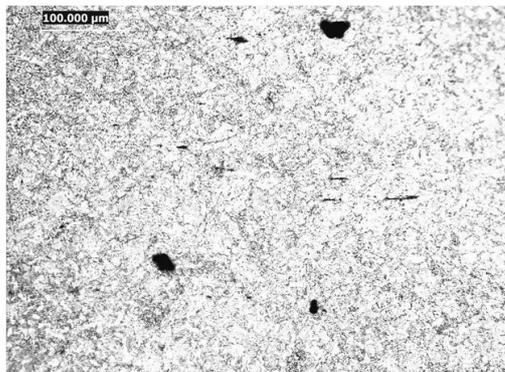
**Fig. 15.** Complete spheroidization of pearlite preceding graphite formation—graphitization at higher temperatures, 500x.

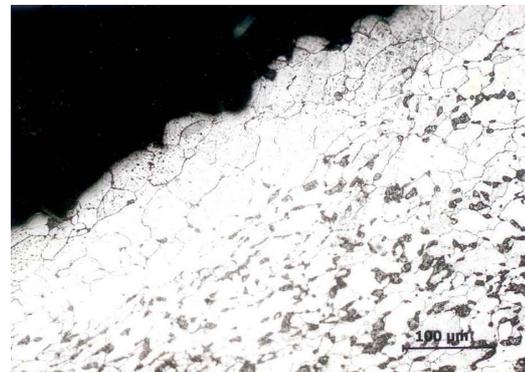
Carbon diffuses from the interior of the metal to the surface where the reaction occurs, depleting the microstructure of carbon and leaving behind essentially pure ferrite. Mechanical strength of the material is reduced due to decarburization. Decarburization is illustrated in Fig. 16.

**Fig. 16.** Decarburization in a platen superheater tube, 200x.

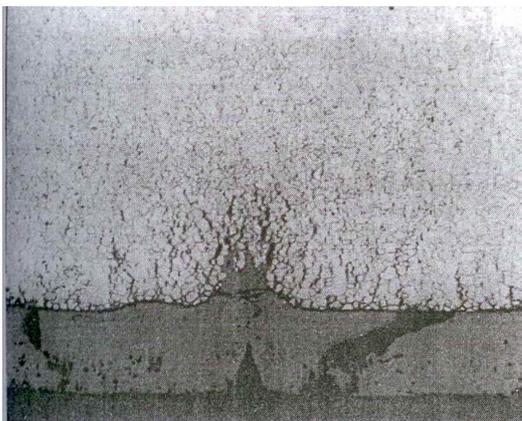
**Fig. 17.** Creep cracks growing from a cusp at metal-scale interface, 200x.

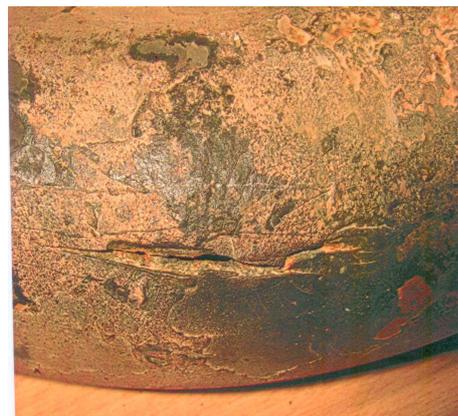
A reheater tube failed through a slit formation at a bend (Fig. 18). No decrease in wall thickness was noted. The microstructure revealed numerous IG fissures in the affected area (Fig. 19). Grain boundary voids were detected in the unaffected zone (Fig. 20), indicating the onset of creep damage.

**Fig. 18.** Slit formation in a reheater tube due to creep.

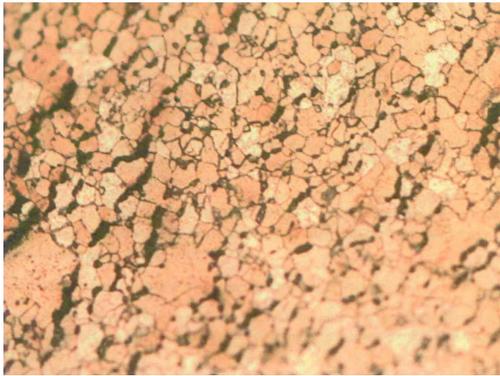
**Fig. 19.** Creep deformation generated IG fissures near fracture, 200x.

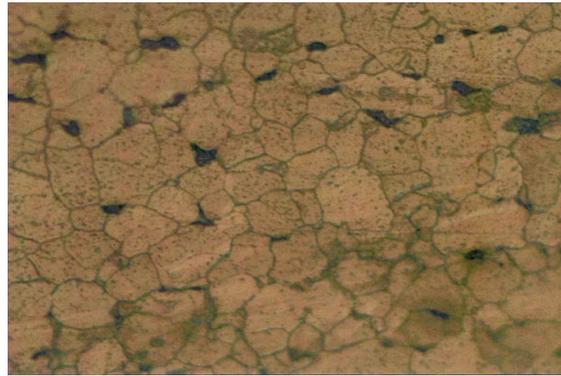
**Fig. 20.** Void formation at grain boundary triple points due creep deformation away from fracture, 200x.

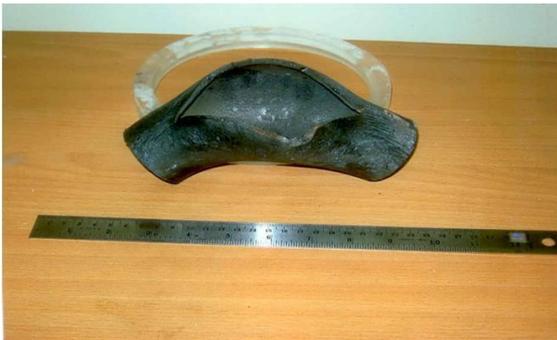
The reheater tube showed a 'thick lip 'fish mouth' failure with some bulging at a bend (Fig. 21). The affected portion revealed excessive grain growth and numerous IG cracks (Fig. 22). The unit was reported to have been in operation for less than two

years, and a creep rupture was not normally expected. Some wall thinning due to erosion by unburnt coal particles was indicated that could have increased the hoop stress at the end. This, in association with decreased strength and intense continuous overheating, was inferred to have led to creep stress rupture.

**Fig. 21.** 'Fish mouth' ruptures of a reheat tube due to grain growth and creep deformation.

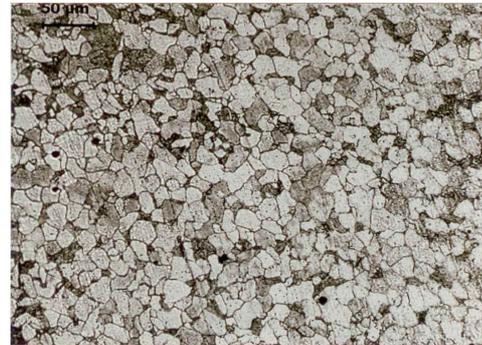
**Fig. 22 (a).** Normal ferrite-pearlite structure in the unaffected portion, 200x.

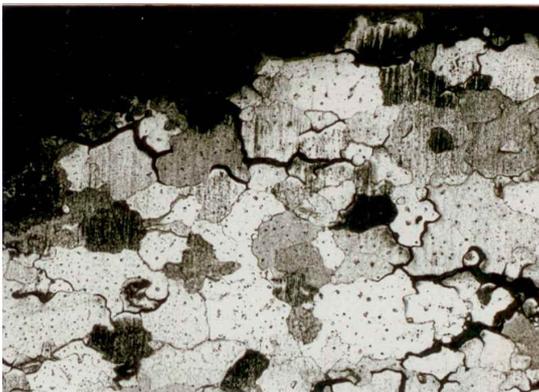
**Fig. 22 (b).** Grain growth and IG cracks revealed in the affected portion, 50x.

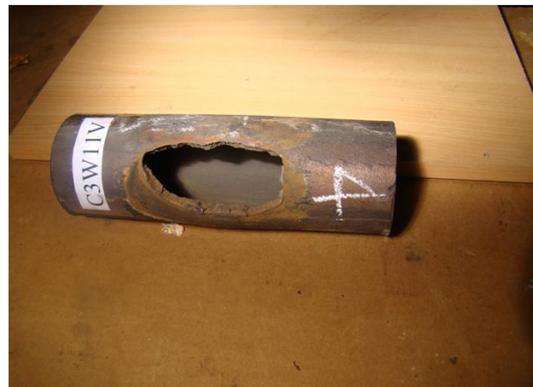
Methane gas collects at grain boundary sites, the pressure of which produces small discrete intergranular fissures that eventually link up to cause a through wall failure. Very often a 'window' type fracture occurs (Fig. 23). The microstructure of the damaged area displays decarburization and IG fissures.

**Fig. 23.** A 'window' type rupture due to hydrogen damage in a waterwall tube.

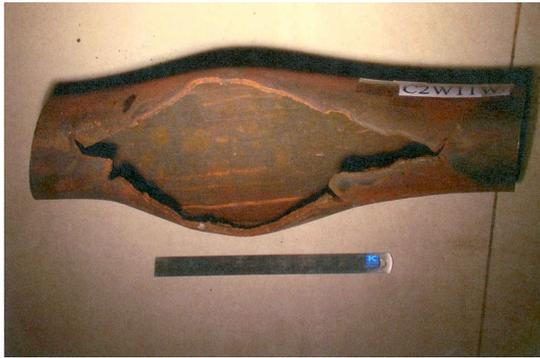
A thick lip 27 cm x 11 cm wide 'fish mouth' type opening was experienced in a waterwall tube (Fig. 24). The microstructure showed decarburization and IG fissures (Fig. 25). SEM fractograph indicated intergranular failure features (Fig. 26).

**Fig. 24.** A 'fish mouth' rupture of a waterwall tube due to hydrogen damage.

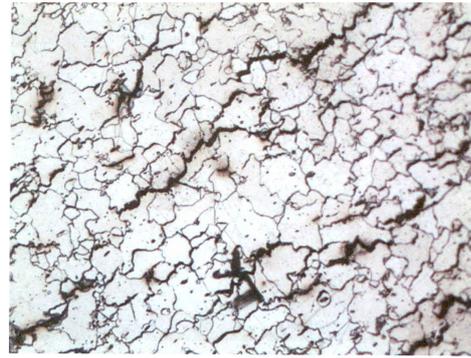
**Fig. 25.** Microstructure showing decarburization and IG fissures in hydrogen attack, 200x.

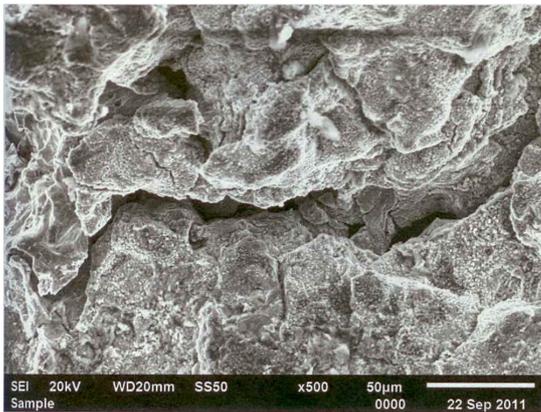
**Fig. 26.** SEM fractograph showing IG fracture features, 500x.

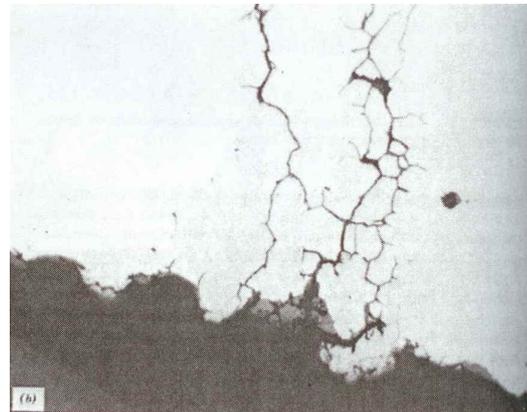
Stress corrosion cracking (SCC) is the failure of a metal stressed in tension below the yield point with simultaneous exposure to a specific corroding environment. Both intergranular and transgranular cracks with branching are observed. Carbon steels exhibit stress corrosion cracking, also known by the name caustic embrittlement, in concentrated hydroxide solutions. The cracking is intergranular in nature (Fig. 27) [2].

**Fig. 27.** Intergranular stress corrosion cracking in ferritic steel, 100x.

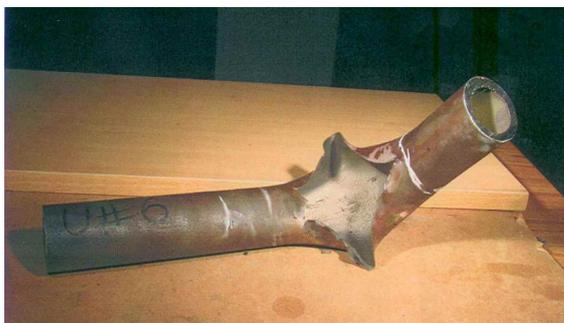
An economizer tube failed with a 'cobra hood' type rupture after a service period of 2 months only (Fig. 28). Severe wall thinning was noted in the affected portion, and the outer surface was smooth and glossy, thus bearing the evidence of heavy erosion. The microstructure approximated that of a 0.1% C steel (Fig. 29), whereas the prescribed tube material was SA-210, having a carbon content of 0.27%. Erosion was evidently high in this softer material in a flue gas containing a high amount of hard alpha quartzite particles.

**Fig. 28.** Ductile 'cobra hood' rupture in an economizer tube.

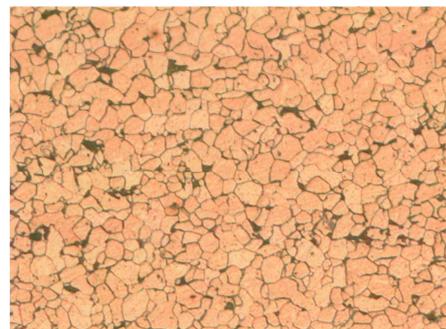
**Fig. 29.** Microstructure shows an approximately 0.1% carbon in steel, 200x.
