SURFACE AND SUBSURFACE FEATURES OF
WORN ALUMINIUM-SILICON BASE ALLOYS.

ABSTRACT

The worn surface of a modified aluminium-silicon eutectic alloy are examined in order to determine the nature of surface damages. Furthermore, an attempt is made to relate the surface features to the mechanism by which the wear particles are formed. Oblique sections of worn materials are used to examine the extent of subsurface changes through both microhardness measurements and metallography observation. The results indicate that both wear features and mechanism are different when the binary eutectic AL/Si alloys are compared to the modified materials.

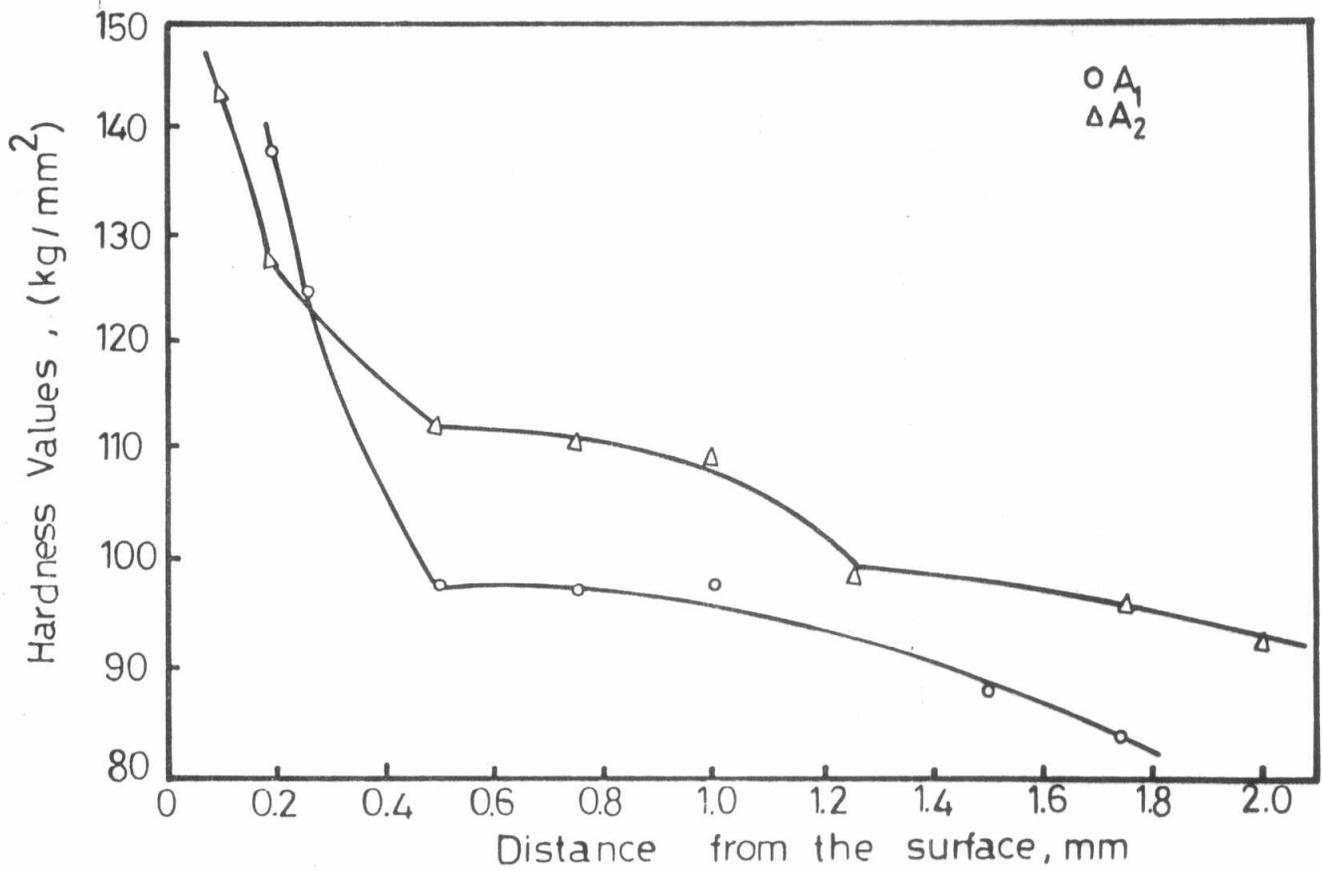
Figure 1. The change in hardness values below the worn surface for the alloys A₁ and A₂.

Furthermore, Fig.(7) shows a dark and unresolved region at one end of the photomicrograph in which presumably, surface wear tracks are produced. This hard formed layer does not have a homogeneous width throughout its length and is been fragmented at its end towards the specimen centre. This layer could well be responsible for the observed increase in hardening near the worn surface, as shown in Fig.(1).

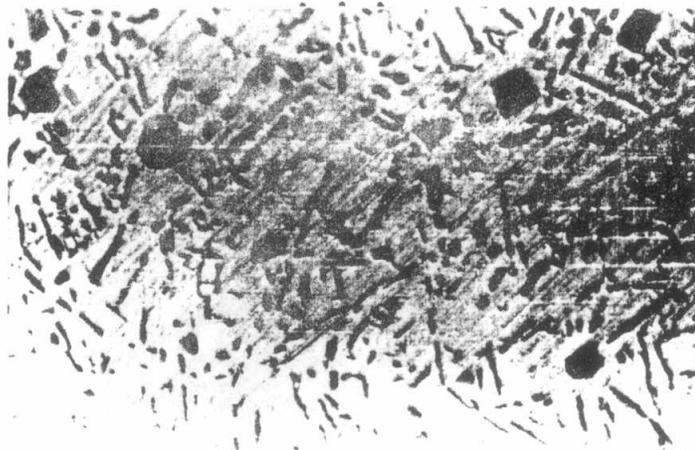
Figure 2. Typical of the microstructure of Allais base alloys, before wear test. (A_3).

Representative specimens from each composition before wear tests are prepared for optical microscopy observation. No significant differences due to alloying elements additions to the basic eutectic structure can be observed in the microstructure, within the limiting power of the microscope, Fig. (2) typical of the observed structure.
